**Flood Control Project Maintenance
Levee Inspections**

Maintenance Issue Types Only, Levee Inspection Report By Mile - Fall 2018

Reclamation District No. 0501 Ryer Island

Waterway	Bank	Unit Miles	Inspection Start/End	Inspector
Unit No. 01 Steamboat Slough	Right	6.71	11/06/2018 11/06/2018	David Julian

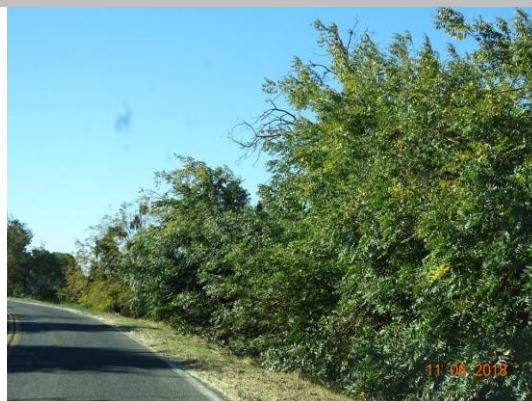
Photo 1 of 1 : FA_2018_RD0501_169_42_20181106_00062.jpg

LM Start	0.06	Rating **	M	Issue No.	42
LM End	0.08	Issue Type +	Ma	Location *	LS
Category	Earthen Levee			GPS Latitude/Longitude	
				Start	End
Item	Trim / Thin Trees			38.253783 °	38.253525 °
				-121.602077 °	-121.602265 °
DWR ID	DWR_RD0501_01_f_2018_42				
Comment Code					
T2 : Thin trees to allow visibility of the ground and room to flood fight.					
Inspector Comment

View looking downstream at relatively thick trees on the land side slope (November 2018).

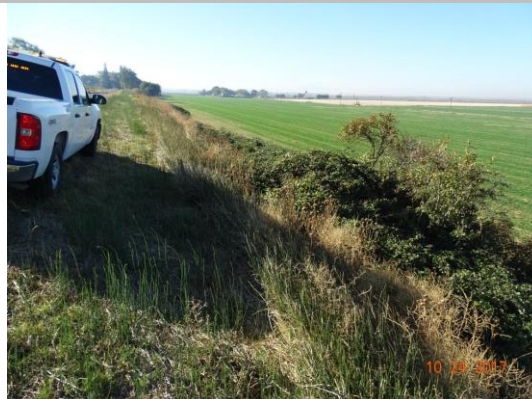
Photo 1 of 1 : FA_2018_RD0501_169_29_20180925_00004.jpg

LM Start	0.76	Rating **	M	Issue No.	29	
LM End	1.01	Issue Type +	Ma	Location *	LS	
Category	Earthen Levee			GPS Latitude/Longitude		
				Start		End
Item	Vegetation			38.243815 °		38.240257 °
				-121.603077 °		-121.603873 °
DWR ID	DWR_RD0501_01_f_2018_29					
Comment Code						
V2 : Remove the wild growth other than native grasses from the levee slopes.						
Inspector Comment						
Landside slope is covered in blackberry vines. Should be removed to allow inspection and access.

Landside slope is covered in blackberry vines. Should be removed to allow inspection and access.

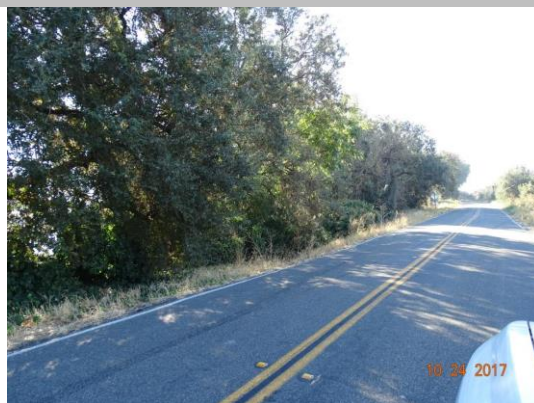
Photo 1 of 1 : FA_2018_RD0501_169_31_20180925_00006.jpg

LM Start	1.01	Rating **	M	Issue No.	31
LM End	1.11	Issue Type +	Ma	Location *	WS
Category	Earthen Levee			GPS Latitude/Longitude	
				Start	End
Item	Vegetation			38.240222 °	38.238918 °
				-121.603887 °	-121.604338 °
DWR ID	DWR_RD0501_01_f_2017_31				
Comment Code					
V2 : Remove the wild growth other than native grasses from the levee slopes.					
Inspector Comment					
Waterside vegetation should be thinned/removed to 20' from WS shoulder to allow inspection and access.

Waterside vegetation should be thinned/removed to 20' from waterside shoulder to allow inspection and access.

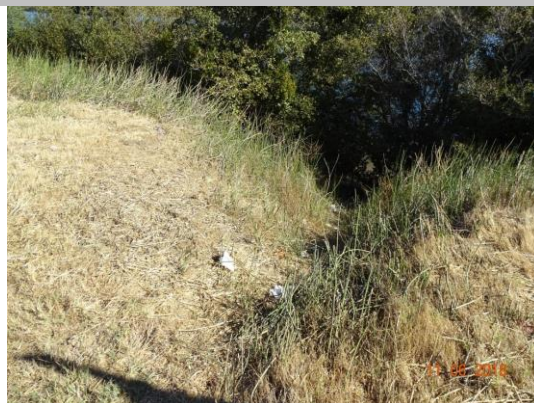
Photo 1 of 2 : FA_2018_RD0501_169_47_20181106_00065.jpg

LM Start	2.07	Rating **	U	Issue No.	47
LM End	2.07	Issue Type +	Ma	Location *	WS
Category	Earthen Levee			GPS Latitude/Longitude	
				Start	End
Item	Slope Stability			38.225070 °	38.225070 °
				-121.603827 °	-121.603827 °
DWR ID	DWR_RD0501_01_f_2018_47				
Comment Code					
S2 : Repair the levee slope damaged by foot traffic and prevent access where possible.					
Inspector Comment					
Deep gouges in the water side slope due to heavy foot traffic. LMA put sign up to deter foot traffic and it has been effective.

View of foot path that is more than 1 foot deep into the water side slope (November 2018).

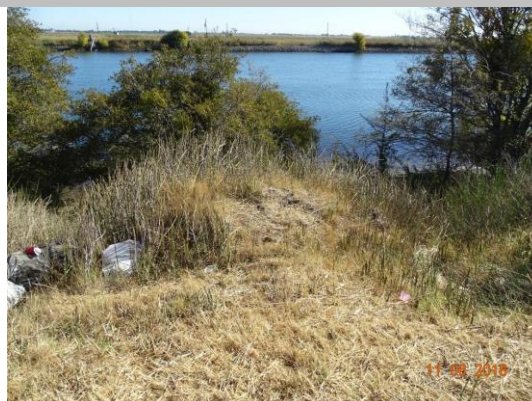
Photo 2 of 2 : FA_2018_RD0501_169_47_20181106_00066.jpg

LM Start	2.07	Rating **	U	Issue No.	47 (cont)	
LM End	2.07	Issue Type +	Ma	Location *	WS	
Category	Earthen Levee			GPS Latitude/Longitude		
				Start		End
Item	Slope Stability			38.225070 °		38.225070 °
				-121.603827 °		-121.603827 °
DWR ID	DWR_RD0501_01_f_2018_47					
Comment Code						
S2 : Repair the levee slope damaged by foot traffic and prevent access where possible.						
Inspector Comment						
Deep gouges in the water side slope due to heavy foot traffic. LMA put sign up to deter foot traffic and it has been effective.

View of two additional foot paths that are more than 1 foot deep into the water side slope (November 2018).

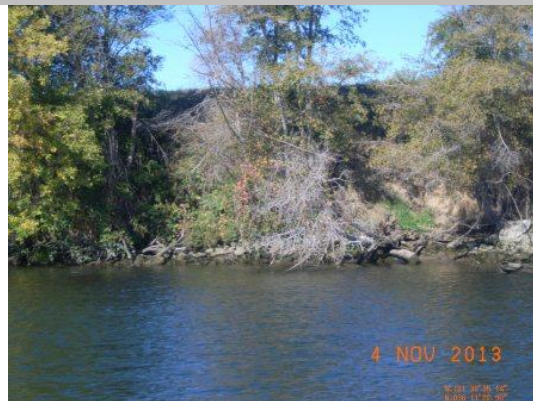
Photo 1 of 1 : FA_2018_RD0501_169_21_20181106_00069.jpg

LM Start	5.77	Rating **	M	Issue No.	21
LM End	5.84	Issue Type +	Ma	Location *	WS
Category	Supplemental			GPS Latitude/Longitude	
				Start	End
Item	2017 USACE Erosion Survey, DRAFT			38.190001 °	38.189311 °
				-121.643160 °	-121.643917 °
DWR ID	DWR_RD0501_01_f_2018_21				
Comment Code					
Inspector Comment					
2017 Site ID: STM 15.7 R					
Status: Eroding					
2017 Field Notes: No observed change.					
Site History: 2008 - Overstepped levee section with multiple small pockets of erosion 10 - 20 ft wide. 2013 - Site has fresh erosion and taller vertical sections.

USACE 2013 Photo #1

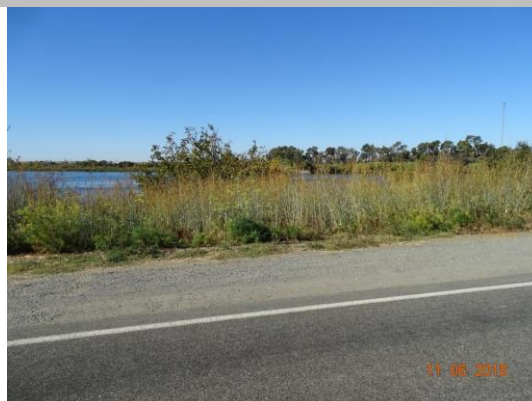
Photo 1 of 1 : FA_2018_RD0501_170_17_20181106_00042.jpg

LM Start	0.16	Rating **	M	Issue No.	17
LM End	0.16	Issue Type +	Ma	Location *	WS
Category	Earthen Levee			GPS Latitude/Longitude	
				Start	End
Item	Vegetation			38.186068 °	38.186068 °
				-121.659012 °	-121.659012 °
DWR ID	DWR_RD0501_02_f_2018_17				
Comment Code					
V1 : Control annual grass and weeds on the levee slopes and easements.					
Inspector Comment

View of thick vegetation at the top of the water side slope (November 2018).

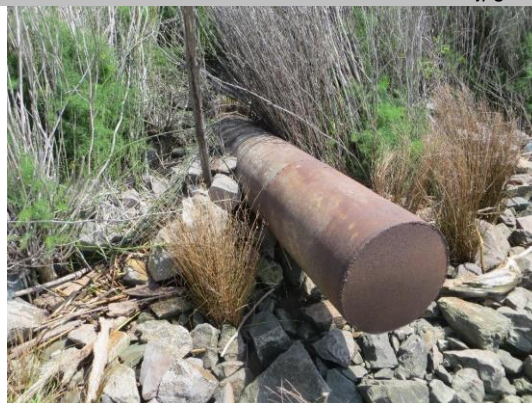
Photo 1 of 3 : UCIP_FA_2018_44753_73955.jpg

LM Start	1.25	Rating **	M	Issue No.	28	
LM End	1.25	Issue Type +	Ma	Location *		
Category	Supplemental			GPS Latitude/Longitude		
				Start		End
Item	DWR UCIP LMA Responsibility			38.201143 °		38.201143 °
				-121.655169 °		-121.655169 °
DWR ID	21085					
Comment Code						
Inspector Comment						
FS_ID:44753						
DS_ID:21085						
EP_NO: N/A						
Repair Type: Non-Urgent						
Crossing Status: Found						
UCIP Comments: Hole rusted through pipe on WS end. Pipe abandoned and should be done so properly.						
FIELD_STRUCT_DESC: *ABANDONED* 20-inch coated steel gravity drainage pipe through the levee, 15.5 feet below the crown. Pipe exposed along the waterside (WS) slope. Steel plate welded over end. [Additional Reference(s): USACE Sacramento O&M Manual 105, April 1959, (HLM 1.4)].						
FS Date: 4/23/2015

20-inch pipe with welded steel plate over end on WS toe.

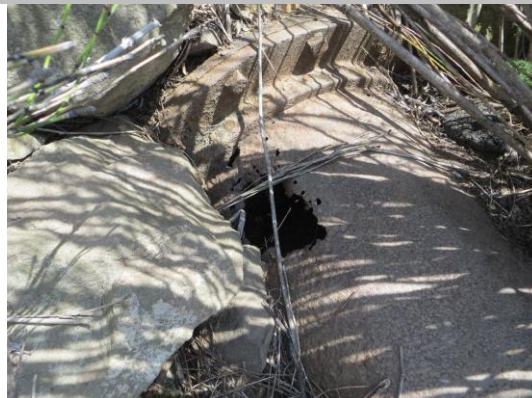
Photo 2 of 3 : UCIP_FA_2018_44753_73954.jpg

LM Start	1.25	Rating **	M	Issue No.	28 (cont)	
LM End	1.25	Issue Type +	Ma	Location *		
Category	Supplemental			GPS Latitude/Longitude		
				Start	End	
Item	DWR UCIP LMA Responsibility			38.201143°	38.201143°	
				-121.655169°	-121.655169°	
DWR ID	21085					
Comment Code						
Inspector Comment						
FS_ID:44753 DS_ID:21085 EP_NO: N/A Repair Type: Non-Urgent Crossing Status: Found UCIP Comments: Hole rusted through pipe on WS end. Pipe abandoned and should be done so properly. FIELD_STRUCT_DESC: *ABANDONED* 20-inch coated steel gravity drainage pipe through the levee, 15.5 feet below the crown. Pipe exposed along the waterside (WS) slope. Steel plate welded over end. [Additional Reference(s): USACE Sacramento O&M Manual 105, April 1959, (HLM 1.4)]. FS Date: 4/23/2015

Hole in pipe at WS toe.

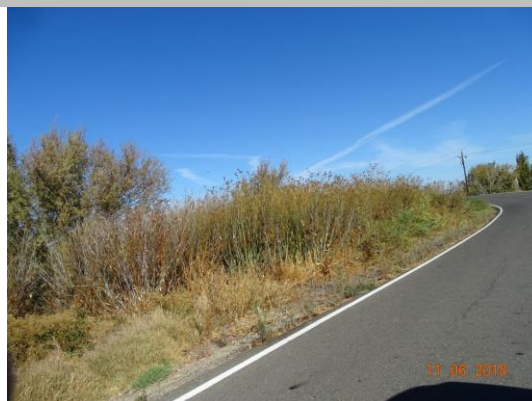
Photo 1 of 1 : FA_2018_RD0501_170_18_20181106_00043.jpg

LM Start	1.73	Rating **	M	Issue No.	18
LM End	1.82	Issue Type +	Ma	Location *	WS
Category	Earthen Levee			GPS Latitude/Longitude	
				Start	End
Item	Vegetation			38.208030 °	38.209040 °
				-121.656052 °	-121.655575 °
DWR ID	DWR_RD0501_02_f_2018_18				
Comment Code					
V1 : Control annual grass and weeds on the levee slopes and easements.					
Inspector Comment					
Remove vegetation from top 20' of water side slope

View looking upstream at vegetation on the water side shoulder (November 2018).

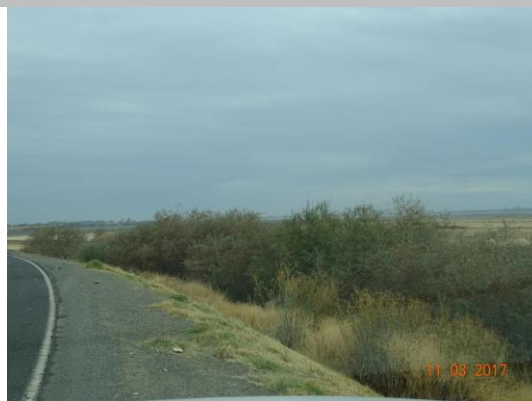
Photo 1 of 1 : FA_2018_RD0501_171_28_20180925_00001.jpg

LM Start	1.48	Rating **	M	Issue No.	28
LM End	1.48	Issue Type +	Ma	Location *	LS
Category	Earthen Levee			GPS Latitude/Longitude	
				Start	End
Item	Trim / Thin Trees			38.244293 °	38.244293 °
				-121.657843 °	-121.657843 °
DWR ID	DWR_RD0501_03_f_2017_28				
Comment Code					
T2 : Thin trees to allow visibility of the ground and room to flood fight.					
Inspector Comment					
Trim/thin willows to allow inspection and access to landside slope and toe.

Trim/thin willows to allow inspection and access to landside slope and toe.

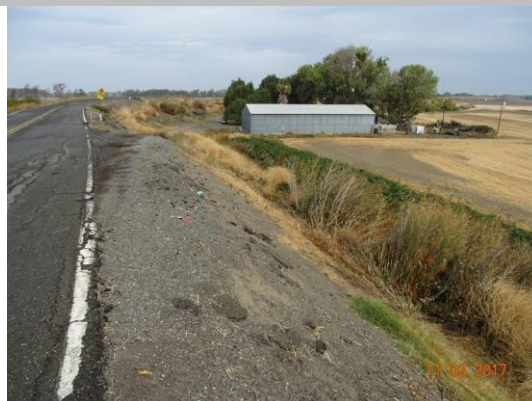
Photo 1 of 1 : FA_2018_RD0501_171_29_20180925_00002.jpg

LM Start	1.56	Rating **	M	Issue No.	29
LM End	1.56	Issue Type +	Ma	Location *	LS
Category	Earthen Levee			GPS Latitude/Longitude	
				Start	End
Item	Vegetation			38.245445 °	38.245445 °
				-121.658035 °	-121.658035 °
DWR ID	DWR_RD0501_03_f_2017_29				
Comment Code					
V2 : Remove the wild growth other than native grasses from the levee slopes.					
Inspector Comment					
Remove berry vines at landside toe to allow inspection and access.

Remove berry vines at landside toe to allow inspection and access.

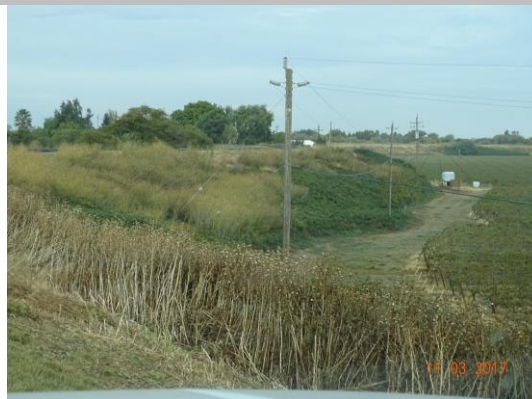
Photo 1 of 1 : FA_2018_RD0501_171_34_20180925_00006.jpg

LM Start	4.47	Rating **	M	Issue No.	34
LM End	4.80	Issue Type +	Ma	Location *	LS
Category	Earthen Levee			GPS Latitude/Longitude	
				Start	End
Item	Vegetation			38.277918 °	38.281507 °
				-121.637670 °	-121.641595 °
DWR ID	DWR_RD0501_03_f_2017_34				
Comment Code					
V2 : Remove the wild growth other than native grasses from the levee slopes.					
Inspector Comment					
Remove berry vines on landside slope and toe to allow inspection and access.

Remove berry vines on landside slope and toe to allow inspection and access.

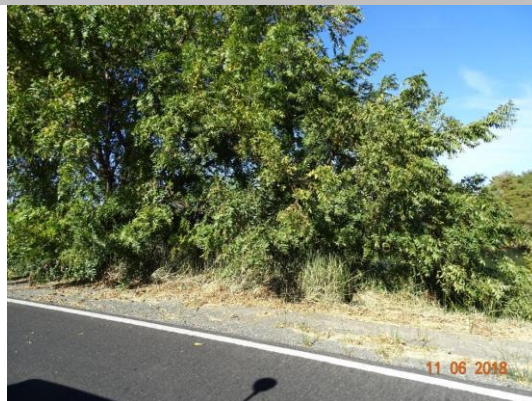
Photo 1 of 1 : FA_2018_RD0501_171_49_20181106_00080.jpg

LM Start	5.61	Rating **	M	Issue No.	49
LM End	5.61	Issue Type +	Ma	Location *	WS
Category	Earthen Levee			GPS Latitude/Longitude	
				Start	End
Item	Trim / Thin Trees			38.289848 °	38.289848 °
				-121.641113 °	-121.641113 °
DWR ID	DWR_RD0501_03_f_2018_49				
Comment Code					
T2 : Thin trees to allow visibility of the ground and room to flood fight.					
Inspector Comment

View of thick tree growth on the water side slope (November 2018).

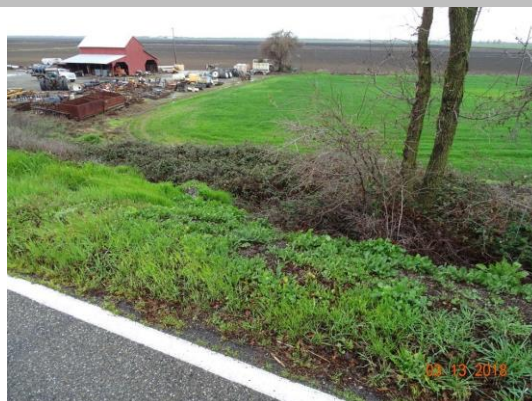
Photo 1 of 1 : FA_2018_RD0501_172_11_20180925_00001.jpg

LM Start	0.84	Rating **	M	Issue No.	11
LM End	0.84	Issue Type +	Ma	Location *	LS
Category	Earthen Levee			GPS Latitude/Longitude	
				Start	End
Item	Vegetation			38.274615 °	38.274615 °
				-121.602718 °	-121.602718 °
DWR ID	DWR_RD0501_04_f_2017_11				
Comment Code					
V2 : Remove the wild growth other than native grasses from the levee slopes.					
Inspector Comment					
Remove thick blackberries at landside toe to allow inspection and access.

Thick blackberries should be removed.
